# Revised Work Plan (RWP) for Additional Characterization of Extent of RIM in Areas 1 and 2 West Lake Landfill Operable Unit-1, Bridgeton, Missouri

WESTLAKE LANDFILL PHOTO DOCUMENTATION OU1 10.20.2015

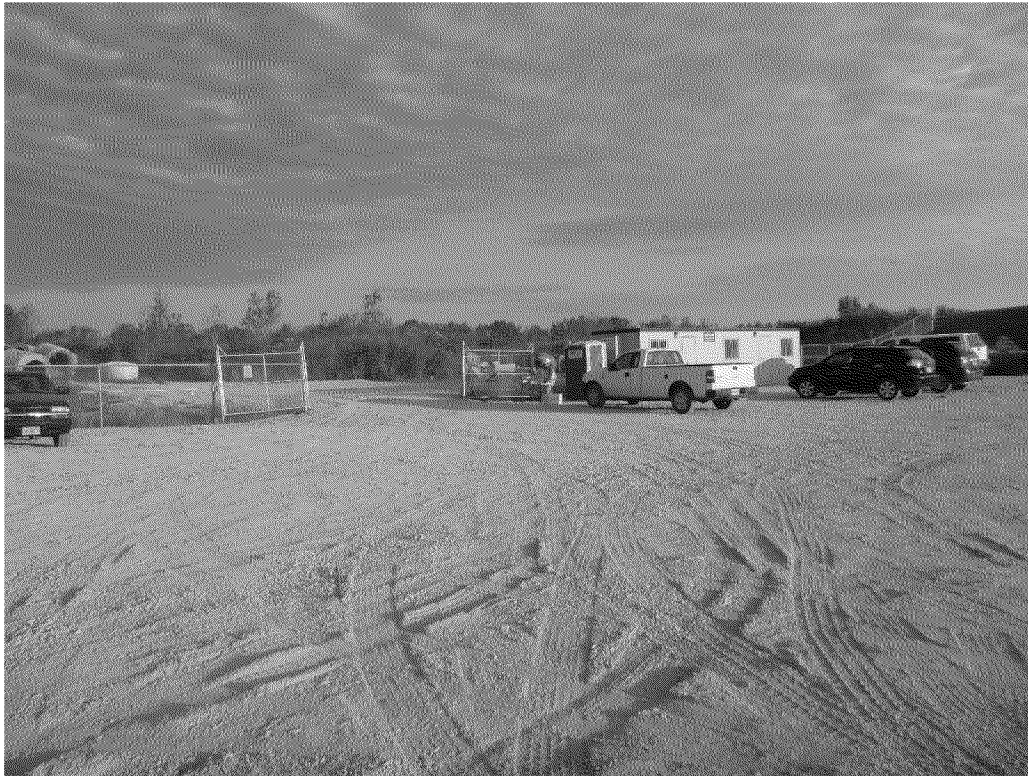
The photo also shows the perimeter gate and fence that surrounds the area. The photo shows that the area is posted with a radiation area sign and trefoil and the gate is locked. This will be the entry / exit point for area operations.

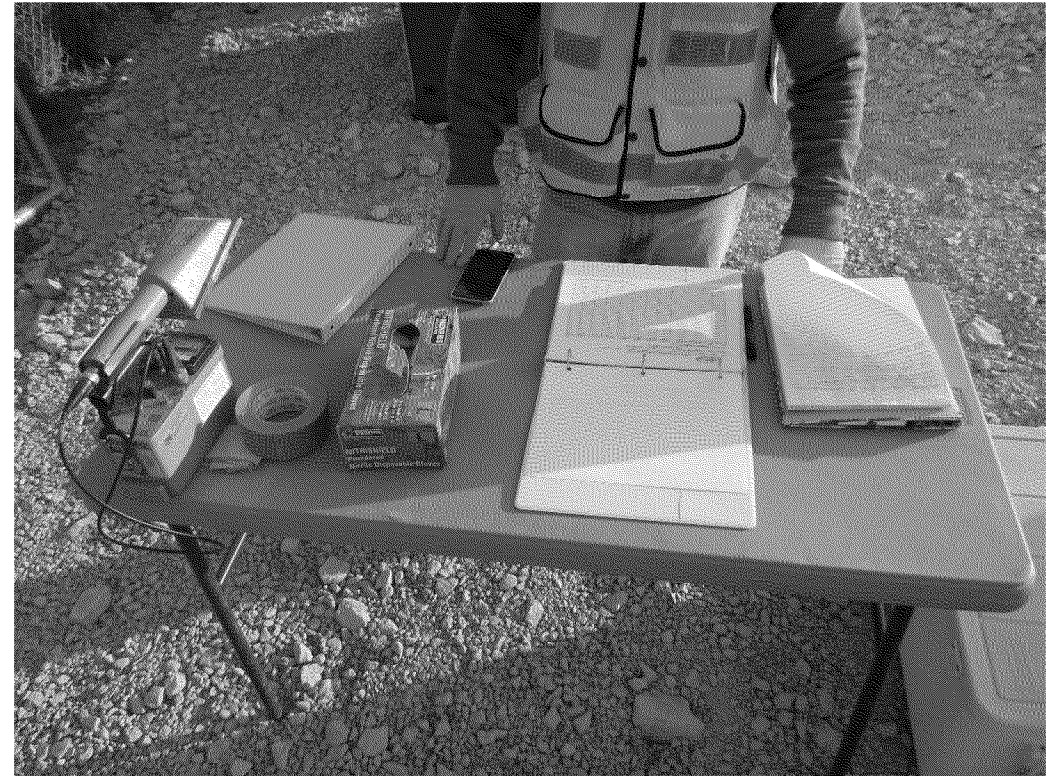
During the site safety briefing, FEI, showed what type of survey meters will be used to conduct measurements on the site as areas are sampled and cleared for the additional work. These were/are used to screen workers and equipment in/out of the area.

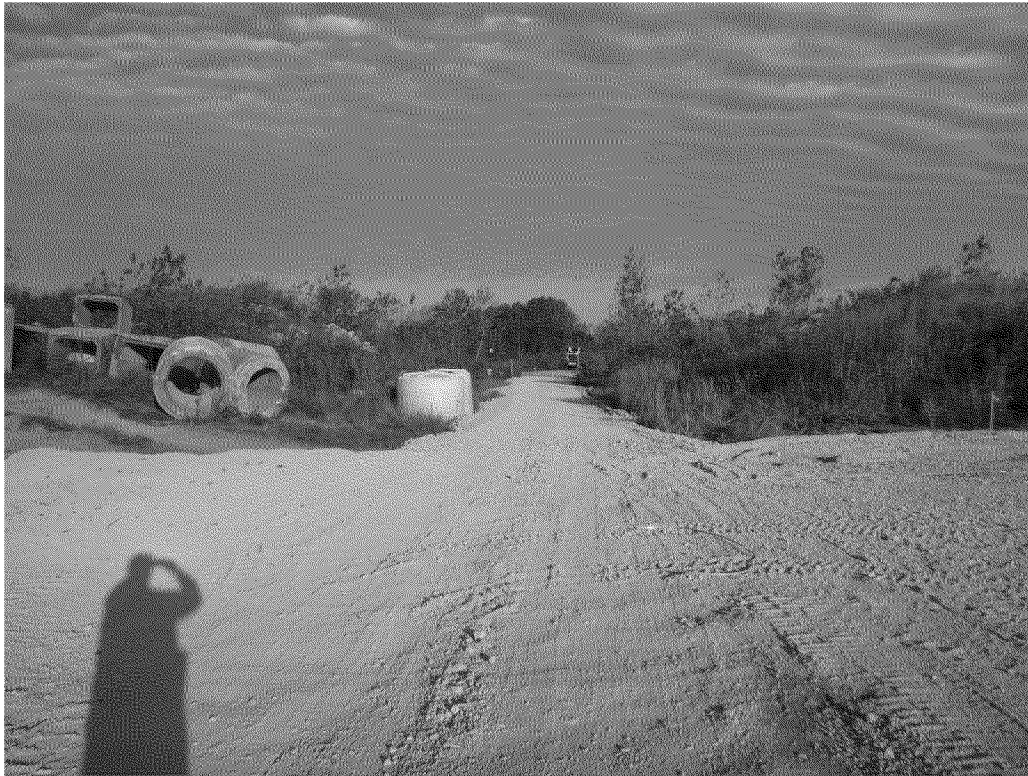
Photo is taken just inside the “hot zone” entrance into OU1 area 2, the view is facing northwest. This is the main alignment pathway and FEI is paving the “finger” pathways 20 – 25 later this week. The photo depicts the pads/roads being built for the additional characterization.

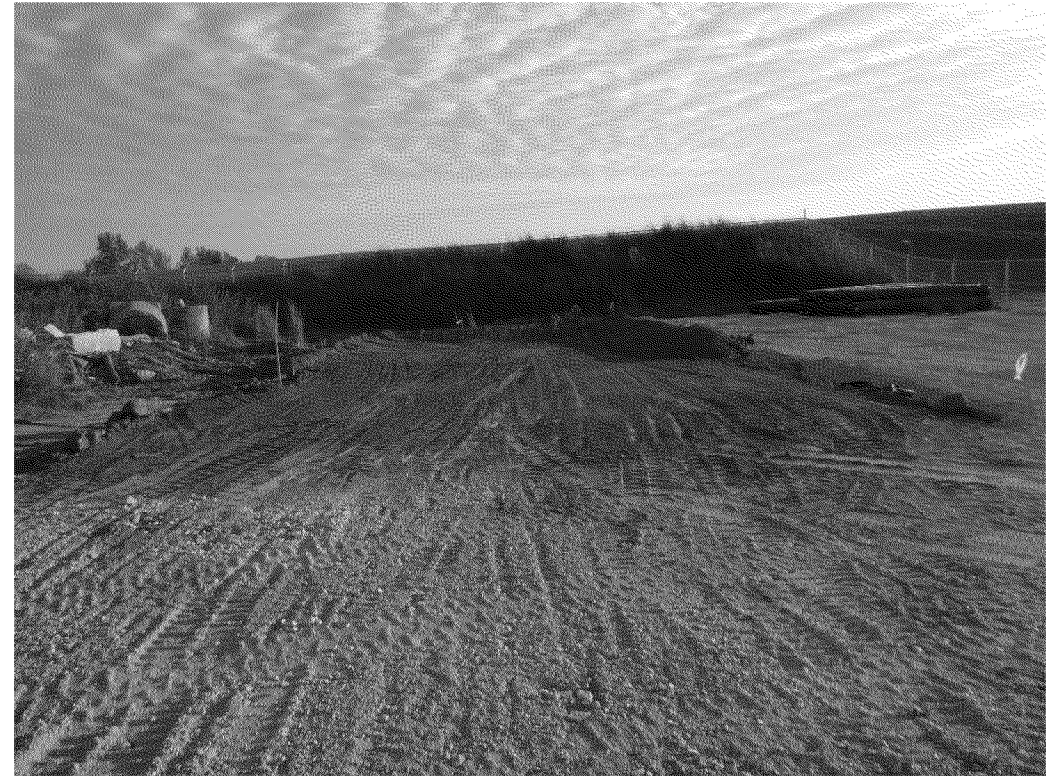
Photo is taken just inside the “hot zone” entrance into OU1 area 2, the view is facing northeast. The photo shows the approximate location where the radiological decontamination pad is being built. The pad will be used to clean and decontaminate vehicles and equipment, if necessary.

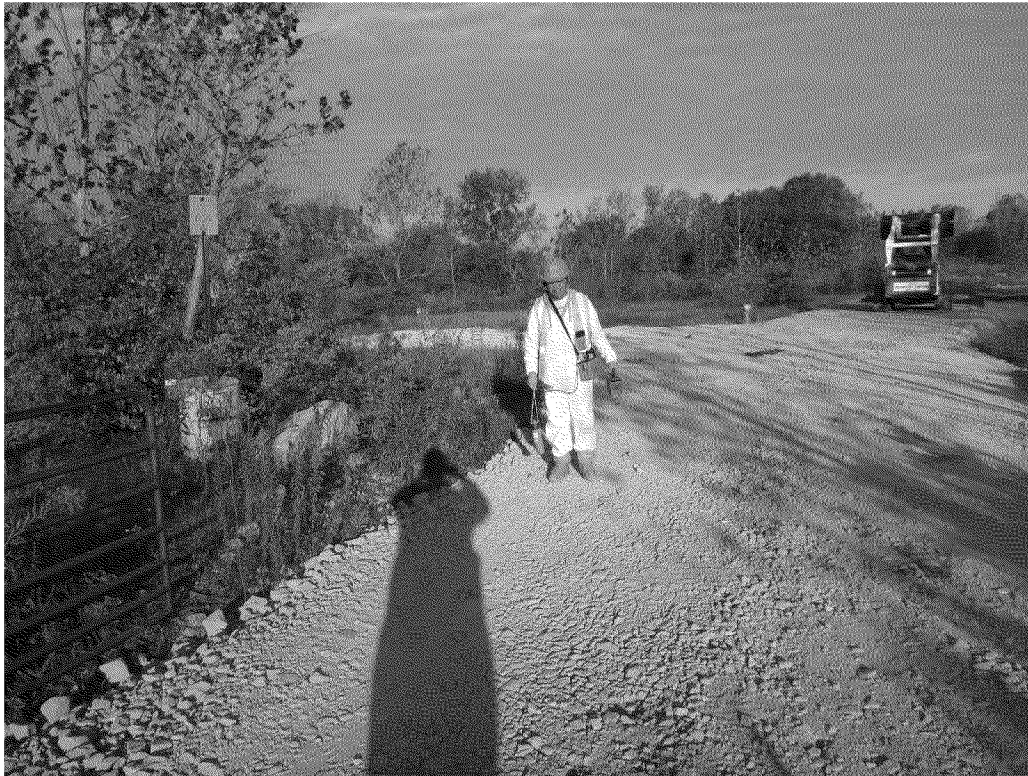
Photo is taken inside OU1, near the reference area #24, the view is facing northeast. The photo is taken approximately 10 yards NE of area 24 and shows the technician performing a survey of the area.

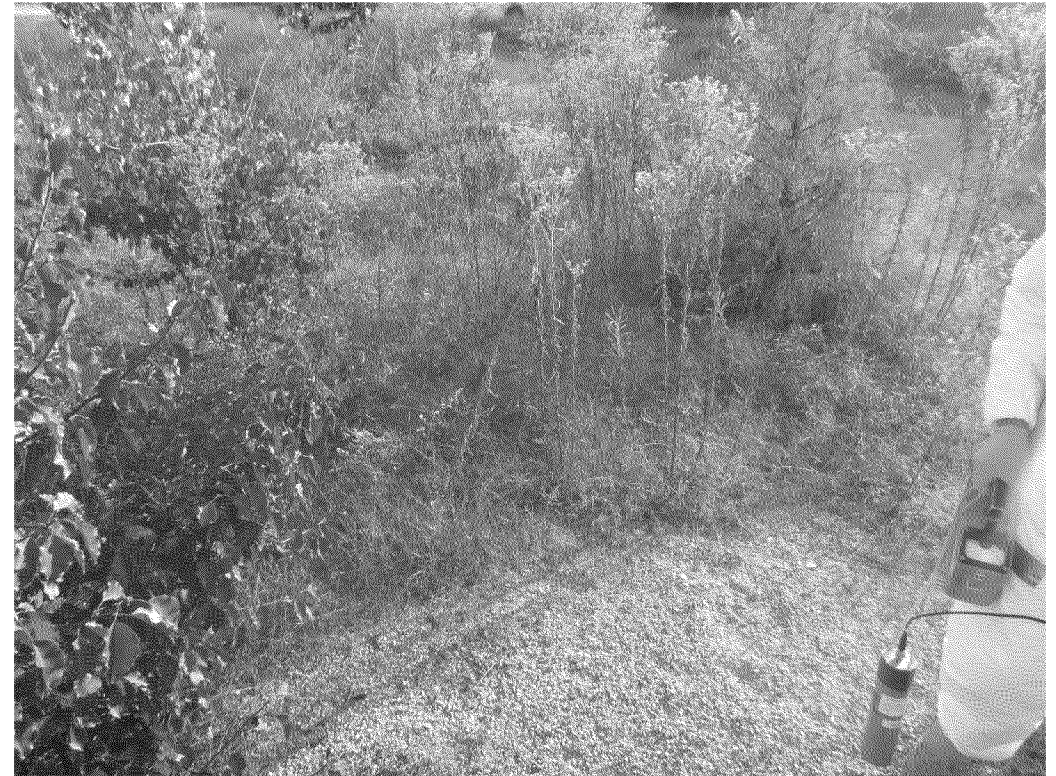
Photo is taken inside OU1, near the reference area #24, the view is facing northeast. The photo is taken approximately 10 yards NE of area 24 and shows the technician performing a survey of the area. This area has been marked for further investigation and will be used as a sampling point for additional characterization.

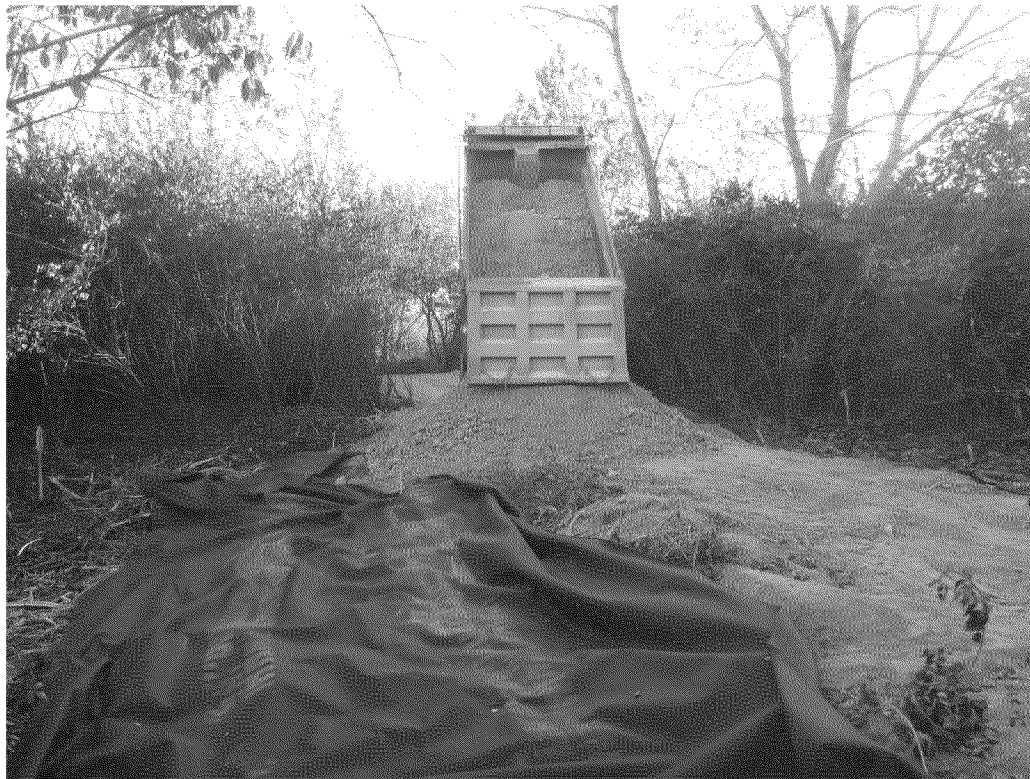
Photo was taken inside OU1; the view is facing east, between paving areas 21-25. The photo shows the progress of the brush cutting/hogging operations in order to have an “alignment line” for the additional characterization. FEI personnel are shown paving and graveling several areas near the reference areas of pathways 23-25.

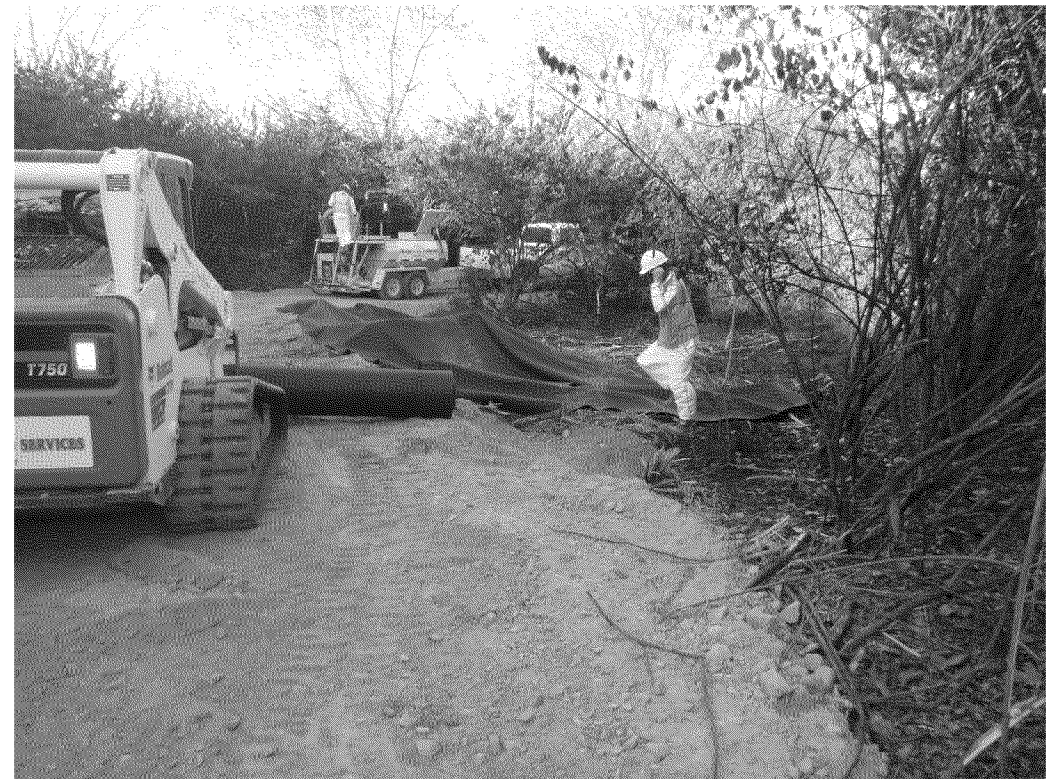
Photo is taken inside the OU1, near the reference area 23, the view is facing west. The pathway is being cleared of debris and vegetation. The photo shows roughly how the area is staked out, the underlayment padding/matting for the path and the crushed gravel used in paving the pathway. The dust suppression method, if necessary, is to lightly wet the material to keep fugitive dust and visible emissions to a minimum in dry and high wind conditions.

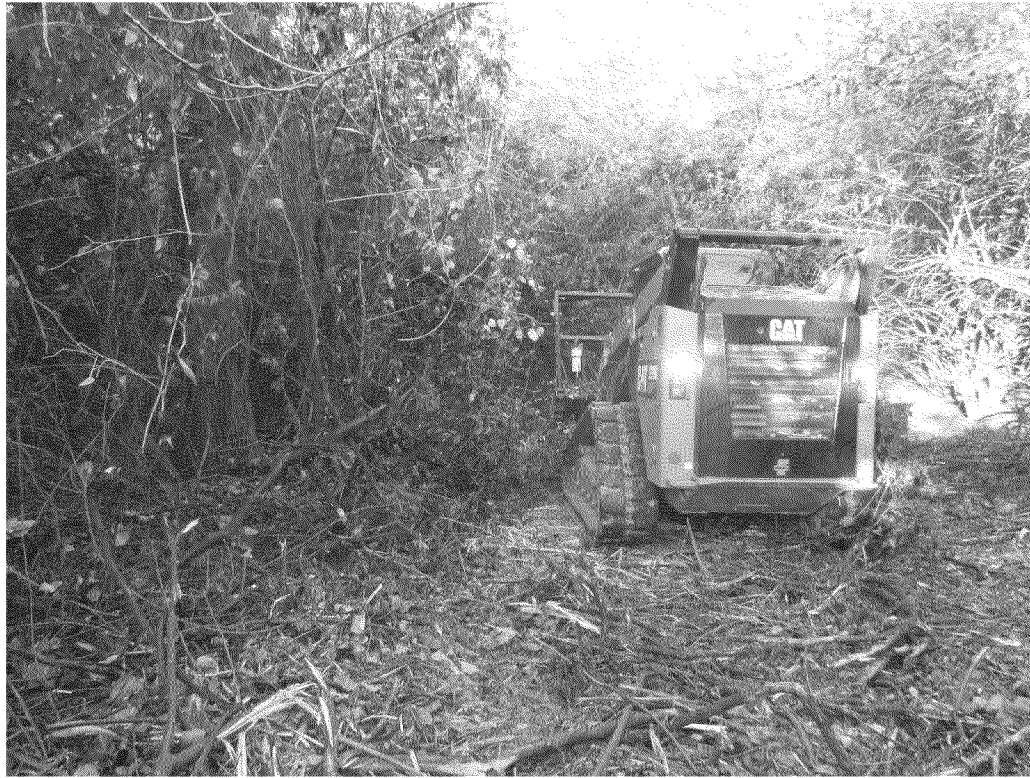
Photo is taken inside the OU1, near the reference area 23, the view is facing west. The pathway is being cleared of debris and vegetation by a forestry mower bobcat. The forestry mower is used to cut small trees and brush.

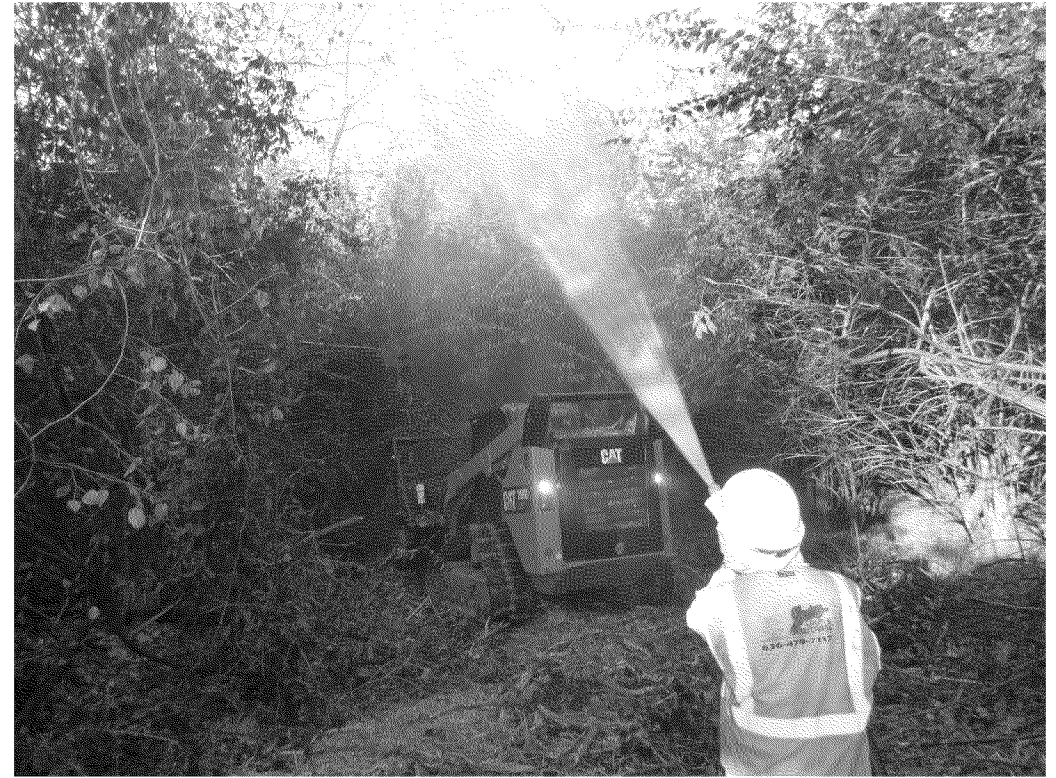
Photo is taken inside the OU1, near the reference area 23, the view is facing west. The pathway is being cleared of debris and vegetation. The dust suppression method, if necessary, is to lightly wet the material to keep fugitive dust and visible emissions to a minimum in dry and high wind conditions. There were no visible dust emissions observed during cutting operations.

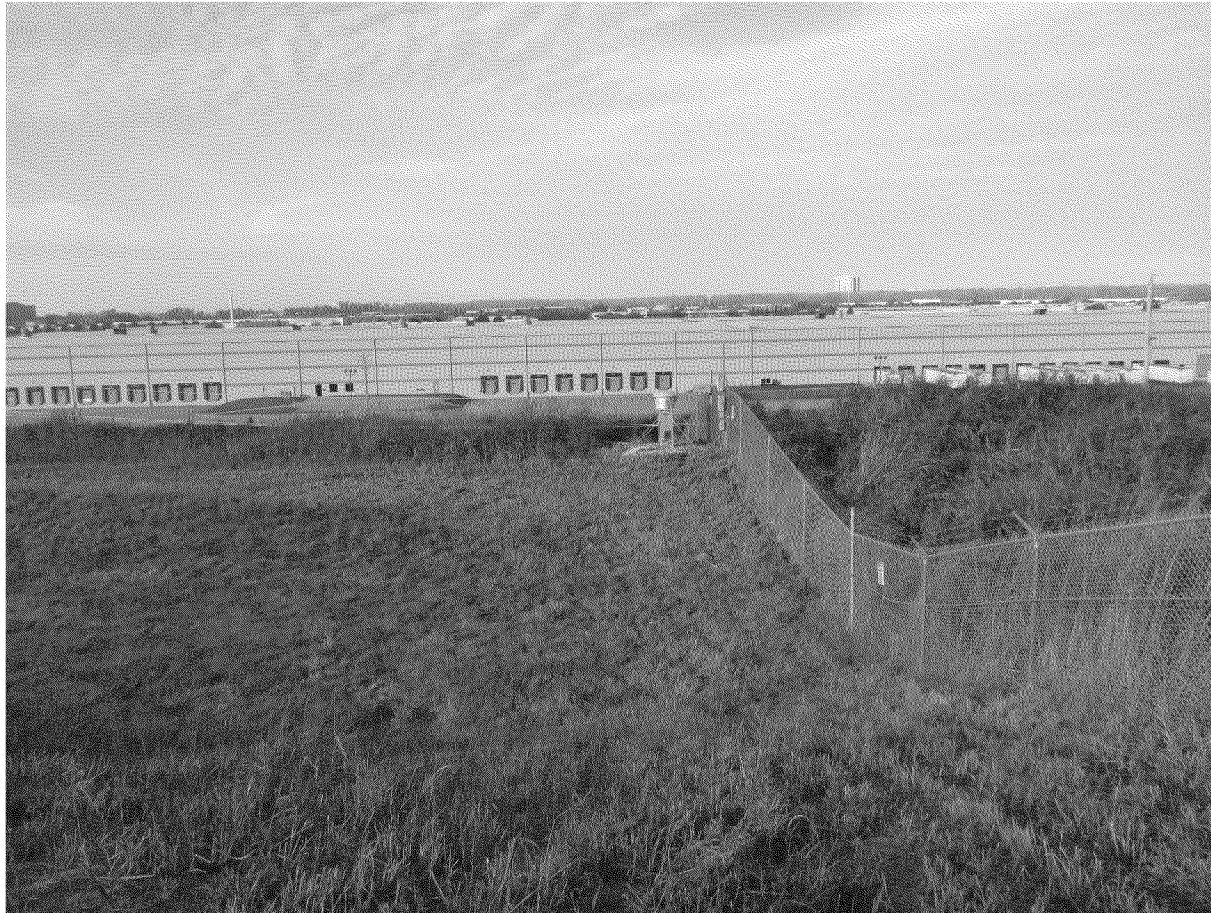
The photo was taken outside the OU1 area, the view is facing west. The photo shows the air monitoring system being used to measure/detect any off-site release at the fence line. The “system” consists of a TLD, Alpha Track Radon detector and a particulate filter. This is 1 of 13 monitors in/around the perimeter of the WLLS.

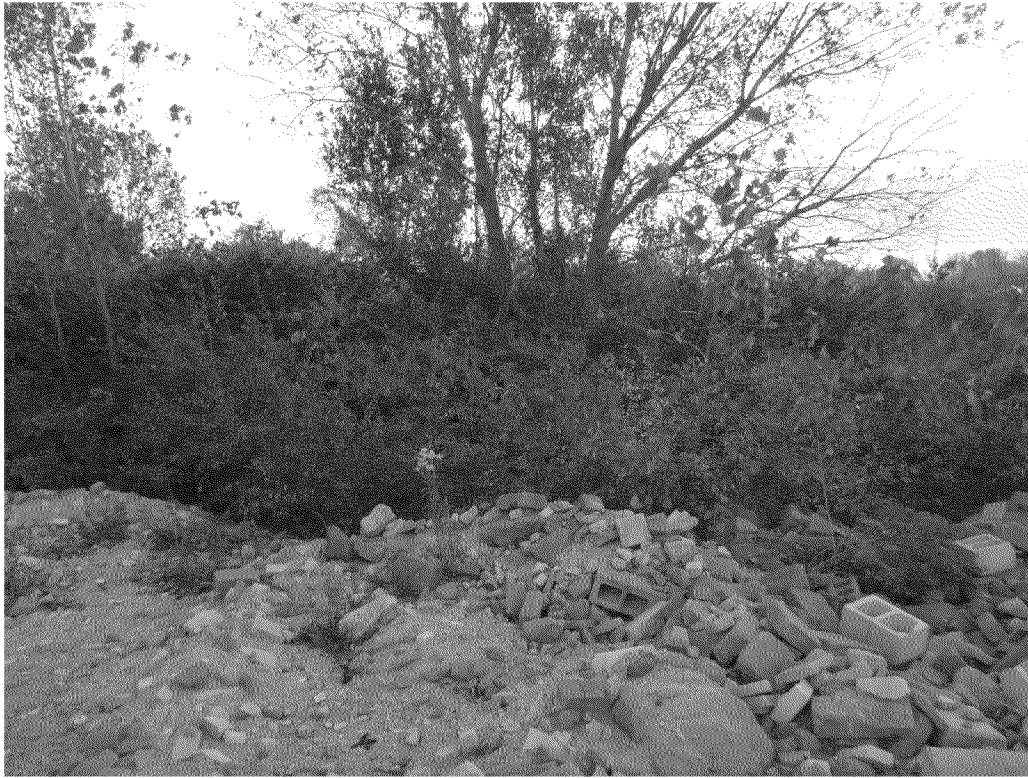
Photo taken between reference areas 17 & 16, inside OU1 area 2, the view is facing east. This is where the extension of the main alignment pathway is to end at reference area #14 for this current phase.

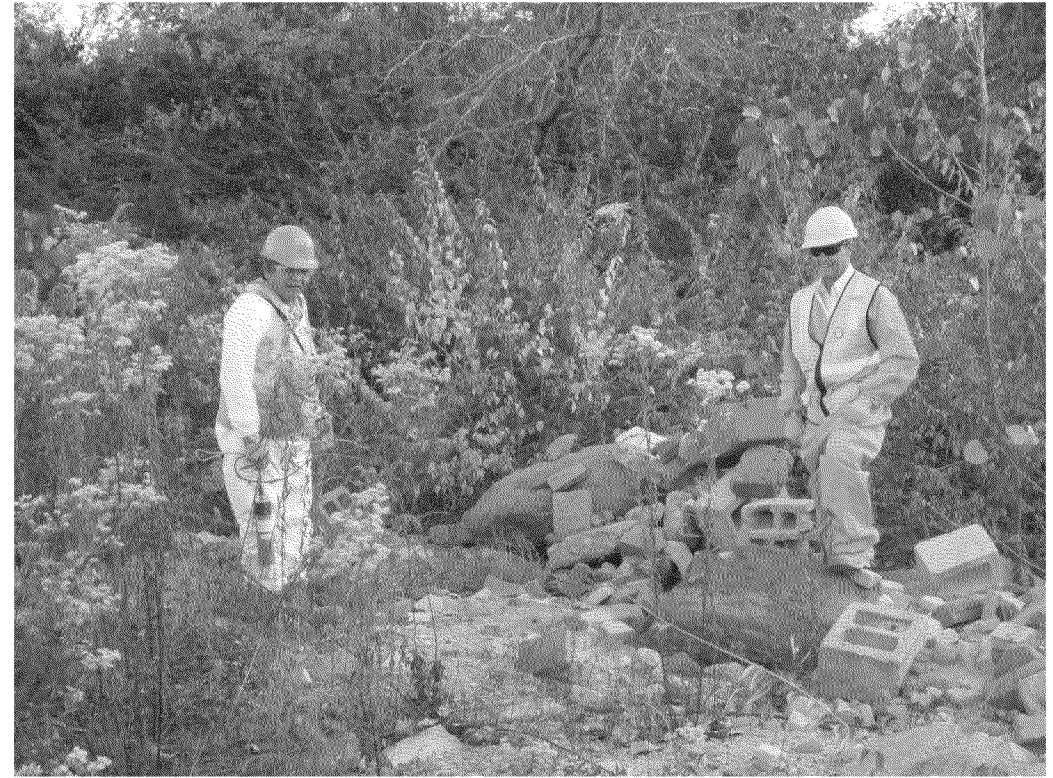
Photo taken between reference areas 17 & 16, inside OU1 area, the view is facing northeast. The photo shows the technician performing a survey of the area.

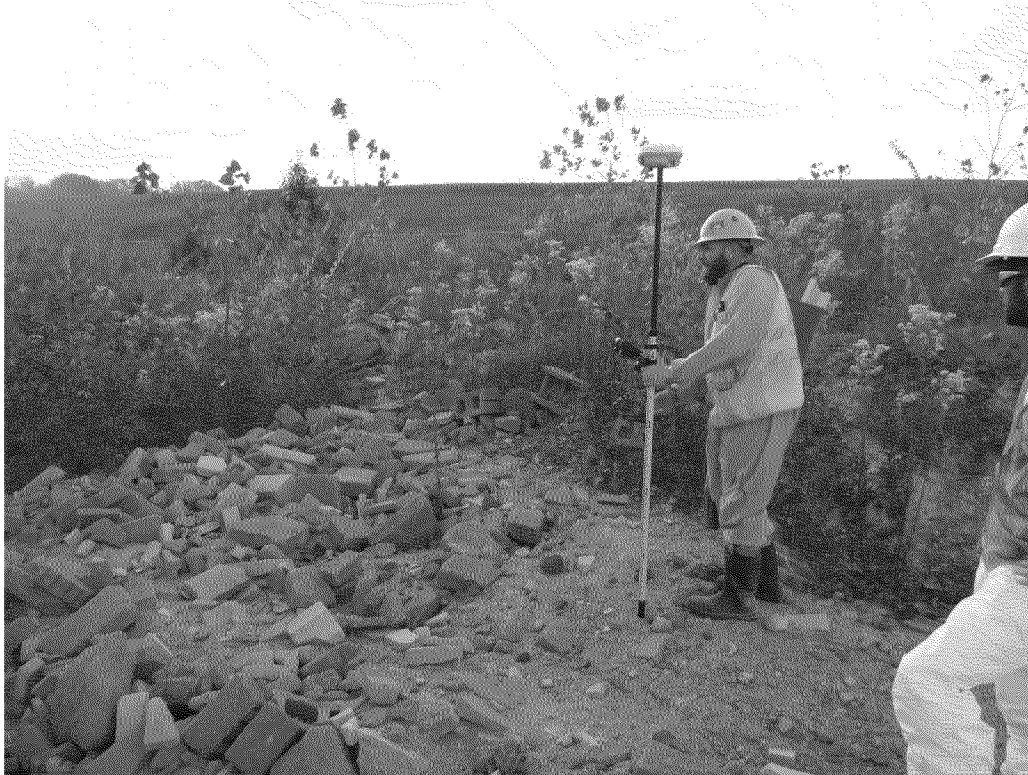
Photo is taken near reference area 16, inside OU1 area, the view is facing southeast. The photo shows the technician performing a GPS survey of the area. This area has been marked for further investigation and will be used as a sampling point for additional characterization of areas 16, 15 & 14.

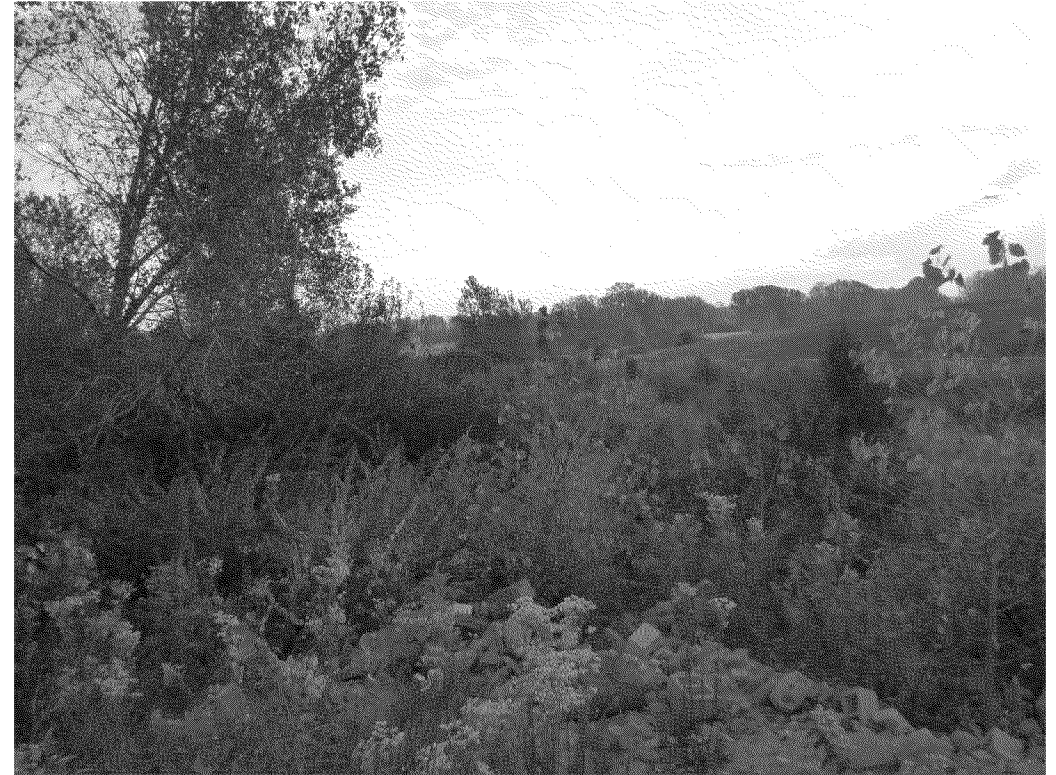
Photo taken near reference area 16, inside OU1 area, the view is facing north. This area has been marked for further investigation.

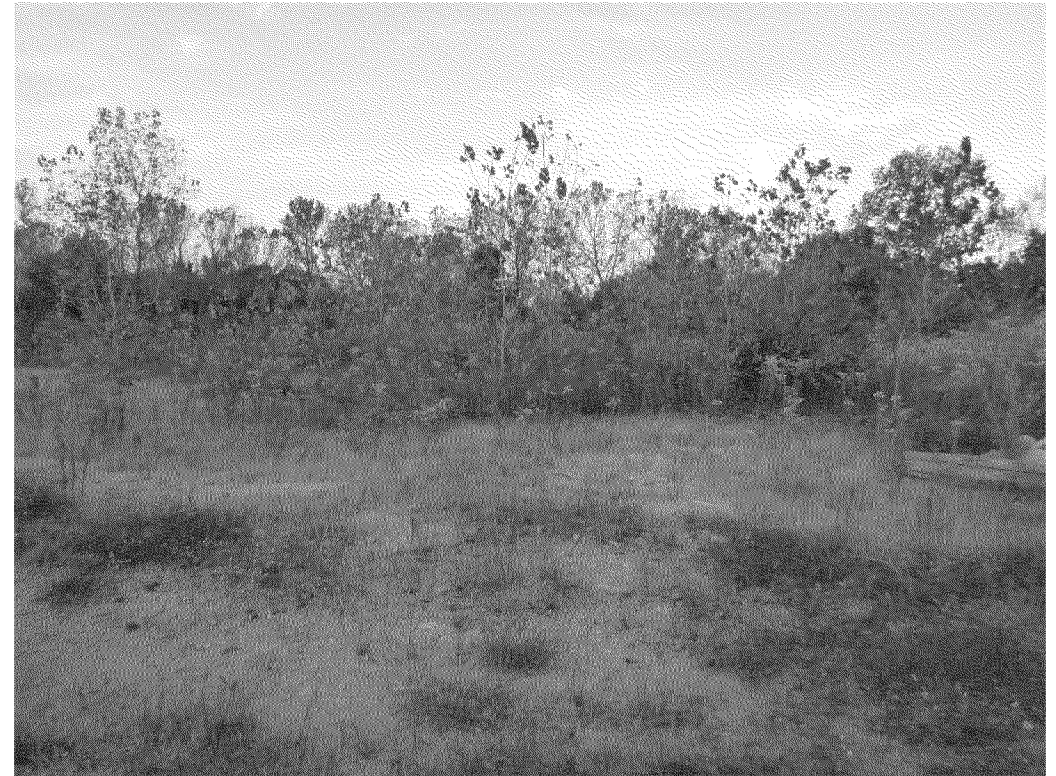
Photo was taken near reference area 19, along the main alignment pathway, inside OUI area 2, the view is facing west. This is where the extension of the main alignment pathway will go into the brush for reference point 19 for additional characterization.

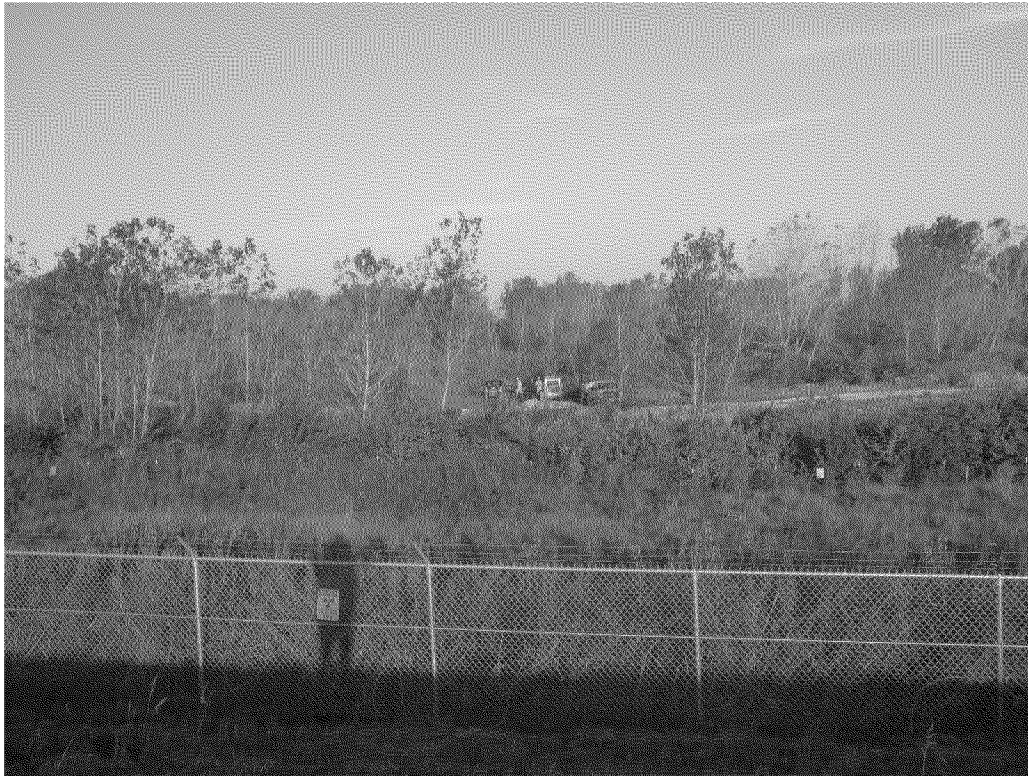
The photo was taken outside OU-1 area 2, showing reference area 17, inside OU1 area, the view is facing northwest. This area has been marked for further investigation and will be used as a sampling point for additional characterization of areas 17, 18, 13, & 12.

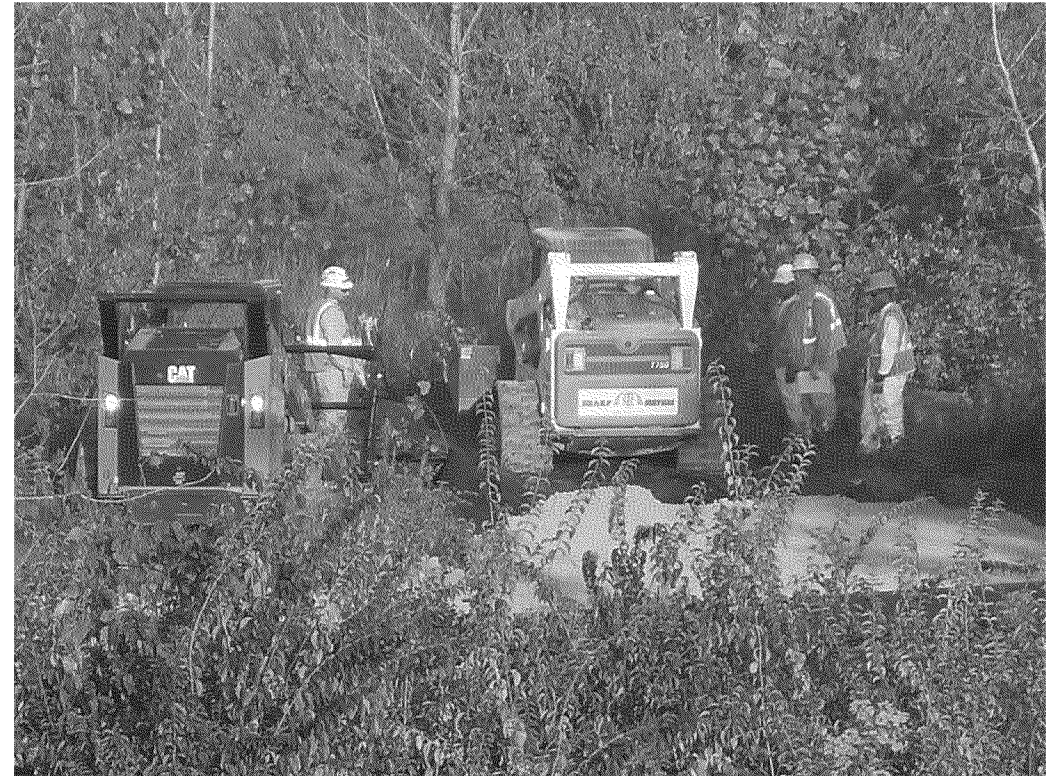
The photo was taken outside OU-1 area 2, showing a close up shot of reference area 17, inside OU1 area, the view is facing northwest.

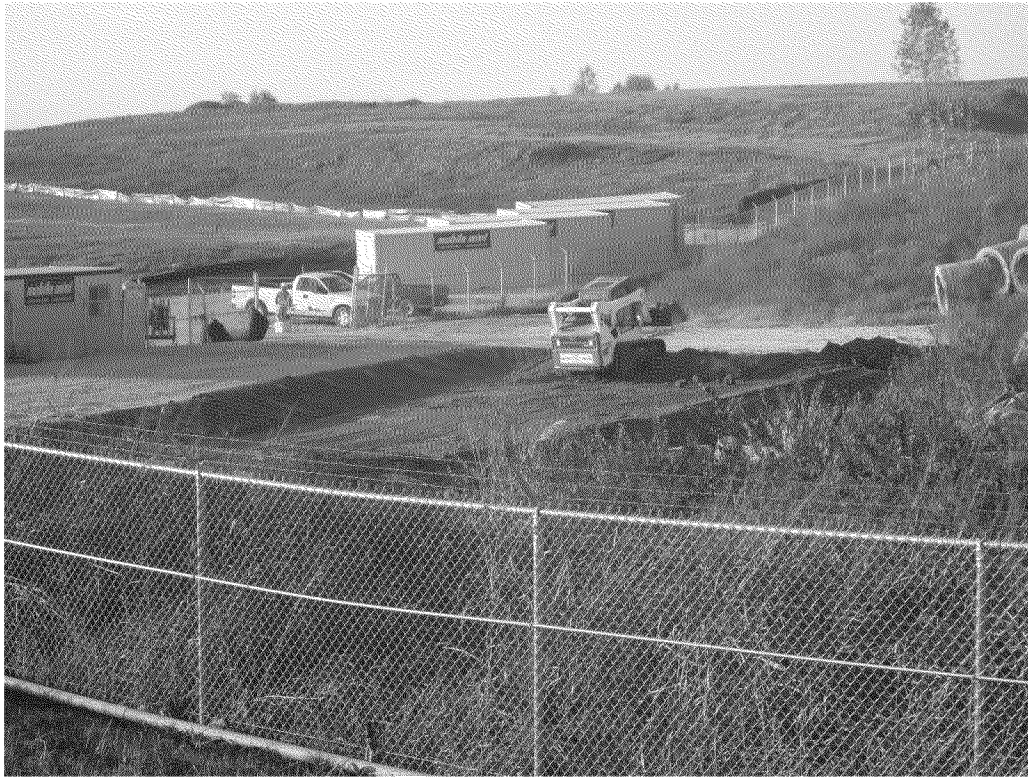
The photo was taken outside OU-1, the view is facing south. The photo shows the construction of the RIM decon area. The pad will be used to clean and decontaminate vehicles and equipment.

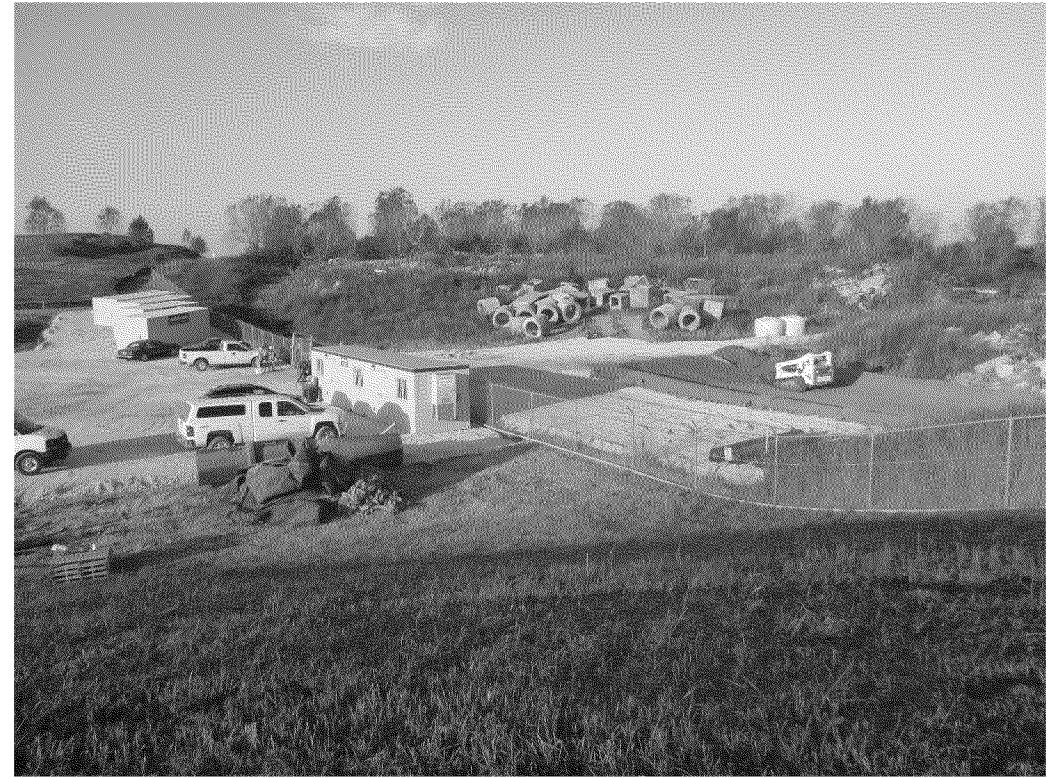
The photo was taken outside OU-1, the view is facing west. The photo is another view of the decontamination area.

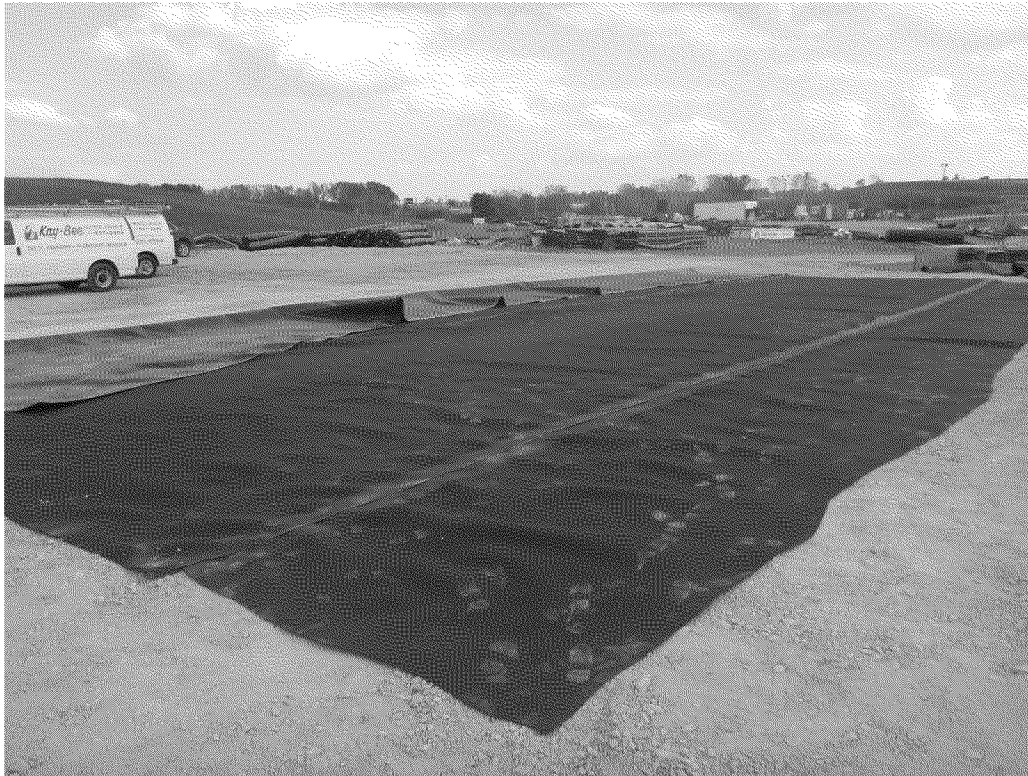
The photo was taken outside OU-1, the view is facing east. The photo shows the under liner for the decontamination area. The liner is about 90' x 50' and will be used to keep water from flowing out of the decon area.

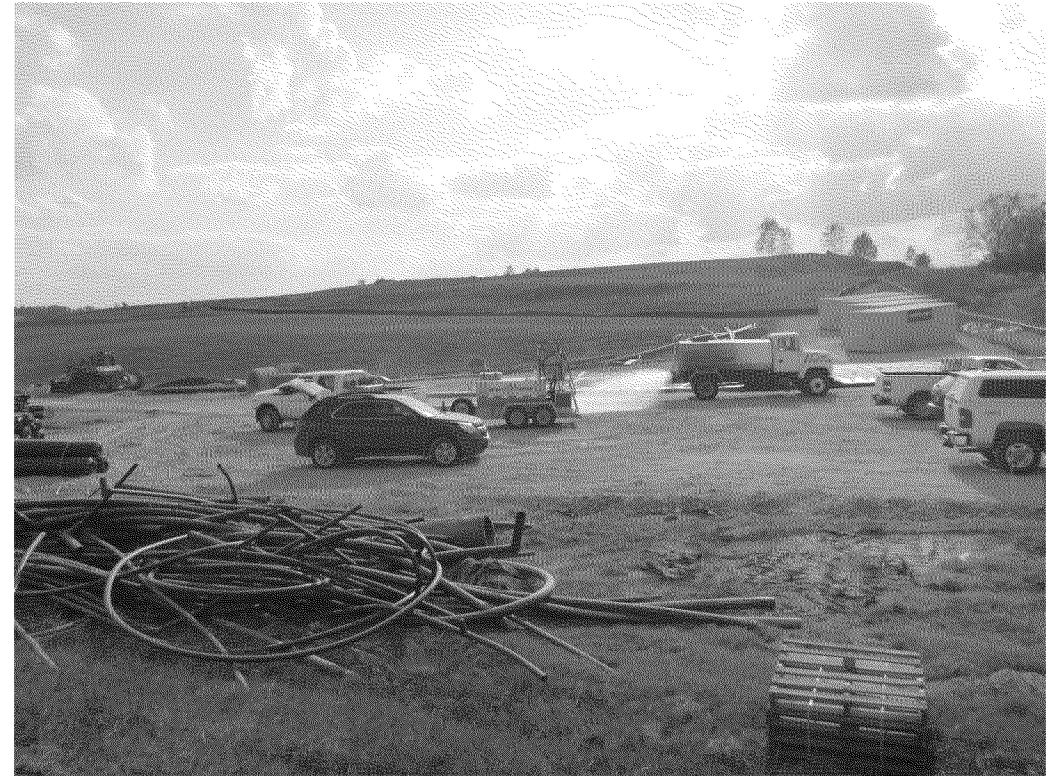
Photo was taken outside the rim area in OU1, the view is facing southwest and shows a one of the water trucks. The water truck provides water for the dust suppression mister/hose being used inside the OU1 area 2 and is also used to mist the roads leading into the area for fugitive dust emission. There were no visible dust emissions observed during this process.

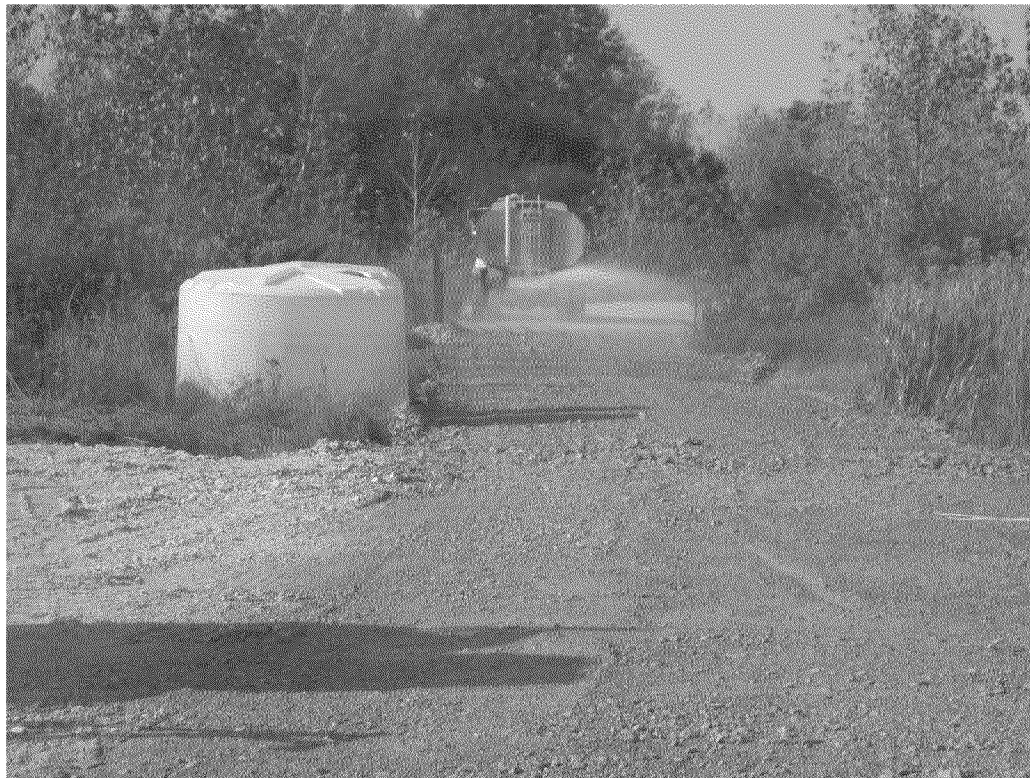
Photo was taken outside the rim area in OU1, the view is facing northwest and shows the water truck in use. The dust suppression method, if necessary, is to lightly wet the material to keep fugitive dust and visible emissions to a minimum in dry and high wind conditions. There were no visible dust emissions observed during this process.

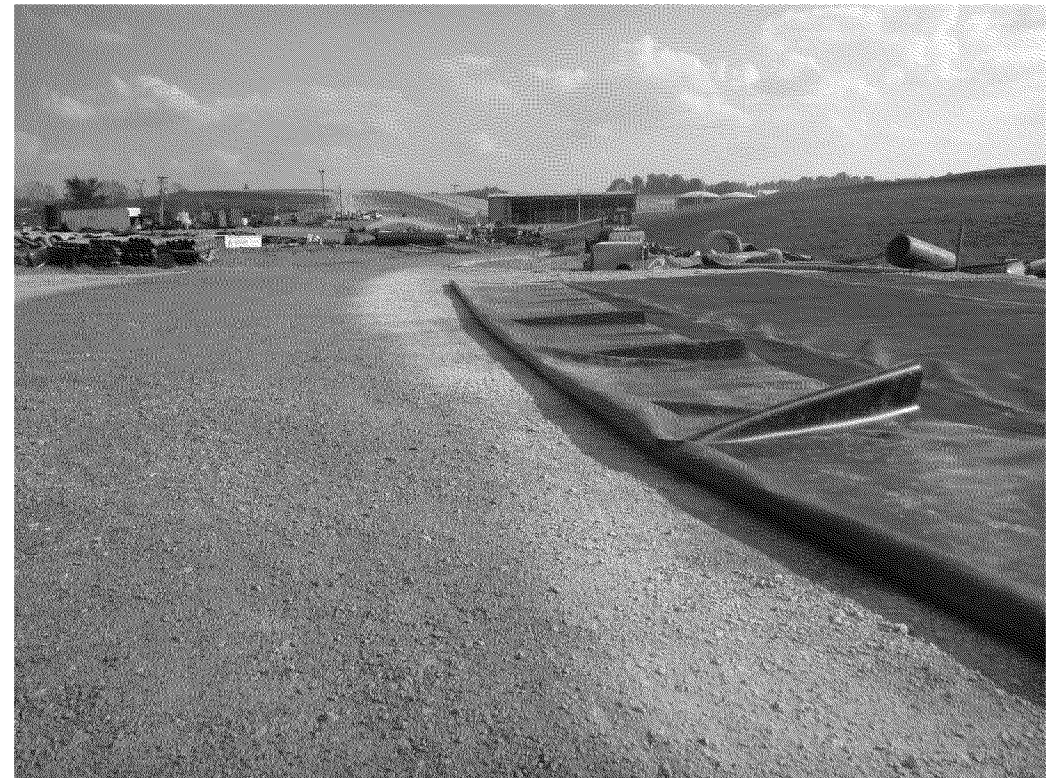
Photo was taken outside the rim area in OU1, the view is facing southeast and shows that the road into / out of OU-1, area 2, has been watered down to keep fugitive dust at a minimum.

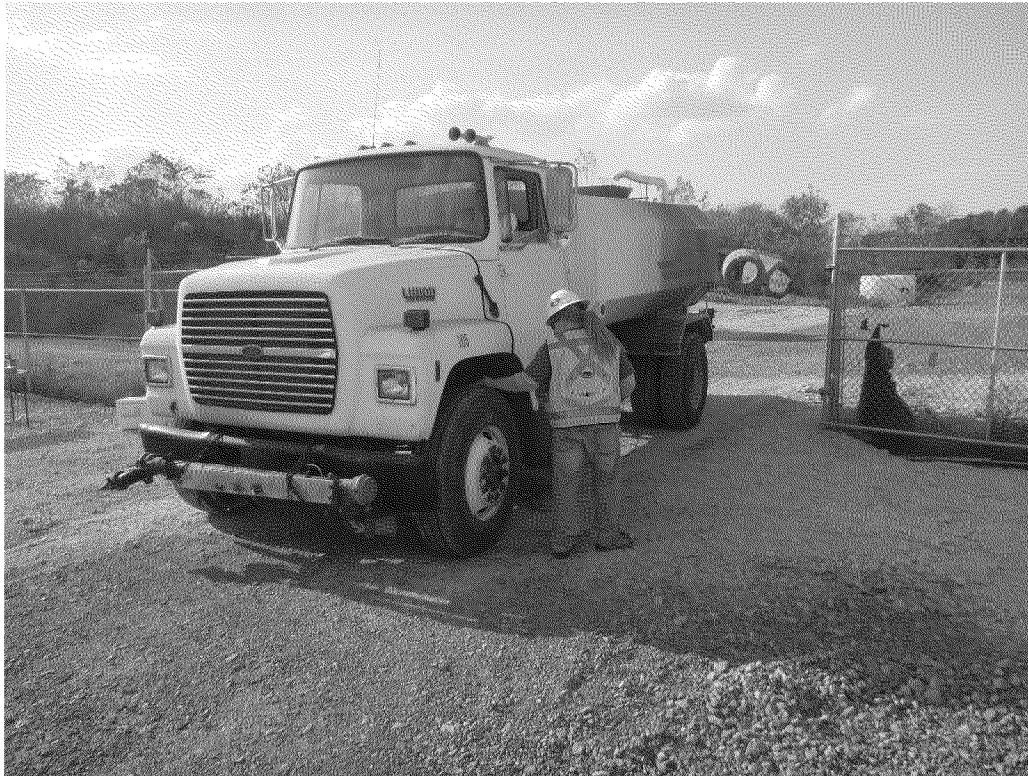
The photo was taken outside the rim area in OU1, the view is facing west. It shows a FEI member conducting RIM screening surveys of workers, vehicles (water tanker truck shown), and equipment in/out of the OU1 area 2.
